# TERN ISLAND SHORE PROTECTION STUDY

Hawaiian Islands National Wildlife Refuge  
French Frigate Shoals, Northwestern Hawaiian Islands

*Prepared for*  
U.S. Fish and Wildlife Service

*By*  
U.S. Army Corps of Engineers  
Honolulu Engineer District

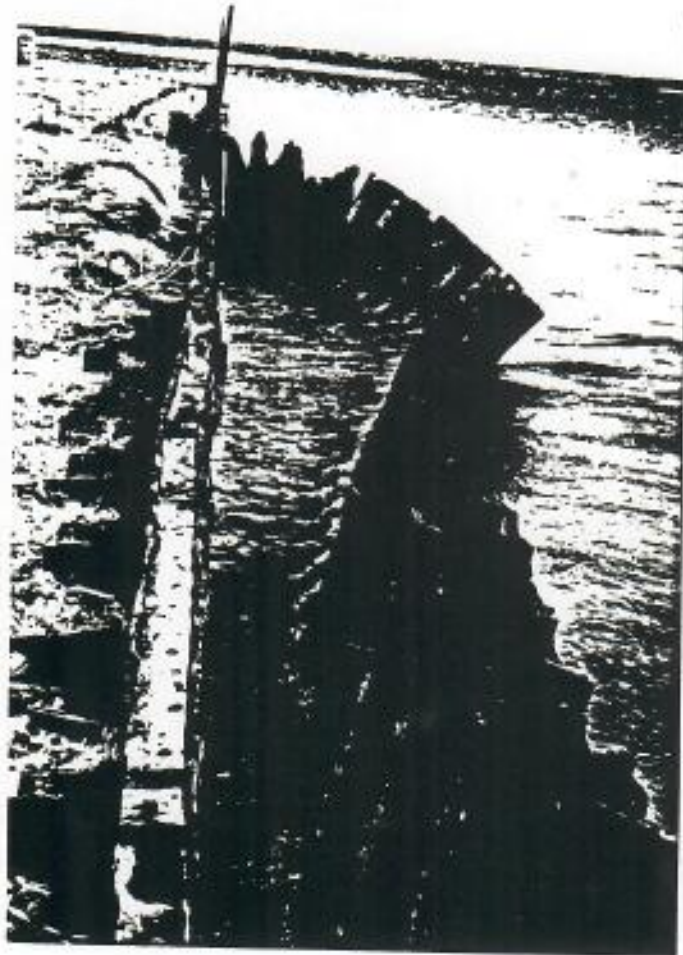
FIGURE 10

The portions of the existing steel sheet pile bulkhead which are subject to failure are adjacent to the deep water of the old Navy ship channel and are vulnerable to overturning due to a lack of any deadman anchoring system (Figure 10). In addition, portions of the sheet pile are sufficiently corroded that they are transparent to wave attack, and the overtopping action has washed coralline fines into the ocean. The sheet pile poses an entrapment hazard to turtles and seals (Figure 11). Entrapment sightings are unpredictable and irregular ( Table 2 ).

(1) Reach 1. Reach 1 is approximately 330 feet long and extends along the west end of Tern Island. Reach 1 is adjacent to the deepest portion of the ship channel, but is not directly exposed to breaking waves due to its generally north-south orientation. The average height of the sheet pile bulkhead in this reach as viewed from land is between 0 and 0.5 feet.

Buckled seawall on west end of Tern Island.

(1) Critical Requirements. The sheet bulkhead along the northern shoreline of Tern Island from Station 0+00 to Station 14+40 requires replacement within the immediate 5 years. In addition, the sheet pile bulkhead from Station 20+00 to Station 28+40 has deteriorated to the point where the upper 3-4 feet of the wall are ineffective against wave attack, and merit replacement to the original elevation of +6.5' MLLW.

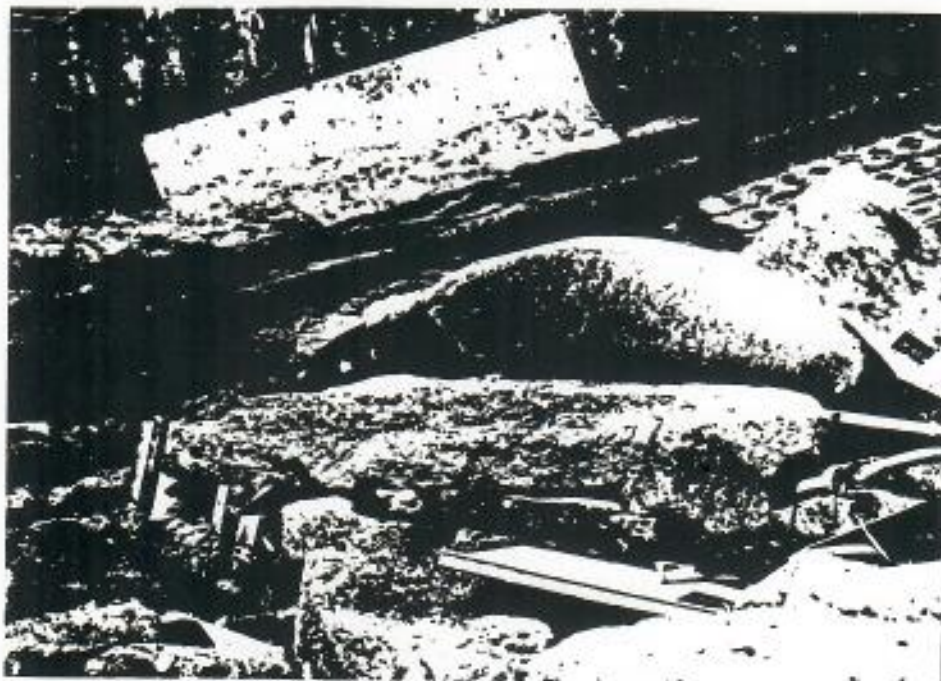
FIGURE 11

Example of potential seal entrapment behind Tern Is. seawall.

1. *Structures must minimize wildlife entrapment hazard in perpetuity.* The selected shore protection measures should not pose entrapment hazards during their functional lifespan. In addition, the shore protection structure should deteriorate in a fashion that its remnants shall not pose a wildlife entrapment hazard at the end of its functional life.
